Manhole Inspection Summary

Manhole # S13II1025MH

Insp Date: **6/12/07 11:37 AM**

Location Address: **4318 PIMLICO ROAD** Cross Street: **BOARMAN AVE**

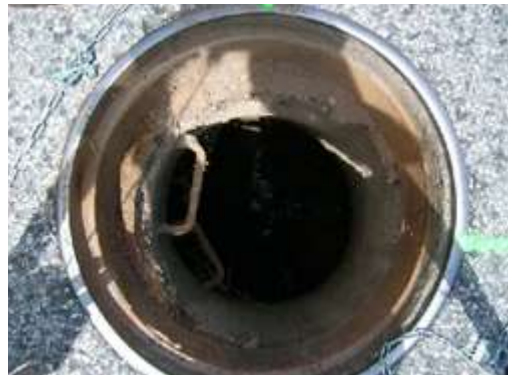
Defect 2

Frame Offset: **2** (in.) Condition: ☒ Sound ☐ Cracked ☐ Leaks

FRAME OFFSET

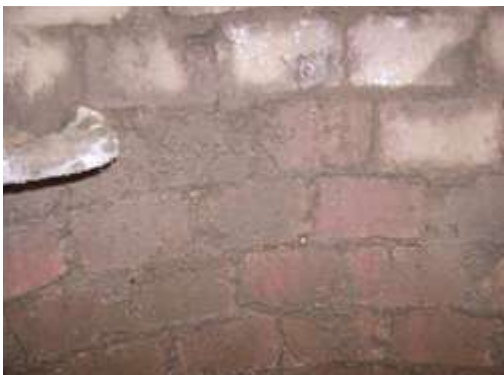
Defect 1

Infiltration: ☐ None ☐ Joint ☐ Cracks ☐ Mortar ☐ Roots ☒ **Wall**

Steps Count: **6** Missing: **0** ☒ **Corroded**

BARREL WALL INFILTRATION AND
CORRODED STEP

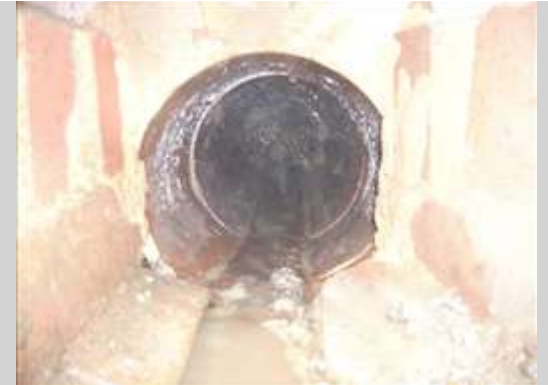
12 O'Clock Outflow

8 in. Circular Gravity Sewer
Pipe Out @ 12 O'Clock

Pipe Height: (in.) Direct
Pipe Material: **Clay** ☐ Pipe Lined
Invert Depth: **10.59** (ft.) Flow Characteristics: **Slow**
Deposits: ☒ None ☐ Mud ☐ Sludge ☐ **Debris** ☐ Grease
Silt Depth: (in.) Deposits Extent:
Infiltration: **Evidence** Pipe Seal Cond: **Sound**

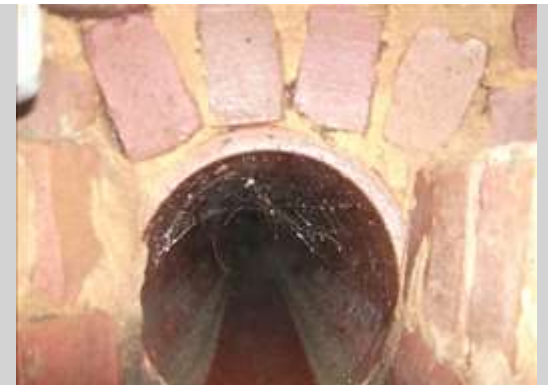
3 O'Clock Inflow

8 in. Circular Gravity Sewer
Pipe In @ 3 O'Clock

Pipe Height: (in.) Direct
Pipe Material: **Clay** ☐ Pipe Lined
Invert Depth: **10.52** (ft.) Flow Characteristics: **Slow**
Deposits: ☒ None ☐ Mud ☐ Sludge ☐ **Debris** ☐ Grease
Silt Depth: (in.) Deposits Extent:
Infiltration: **None** Pipe Seal Cond: **Sound**

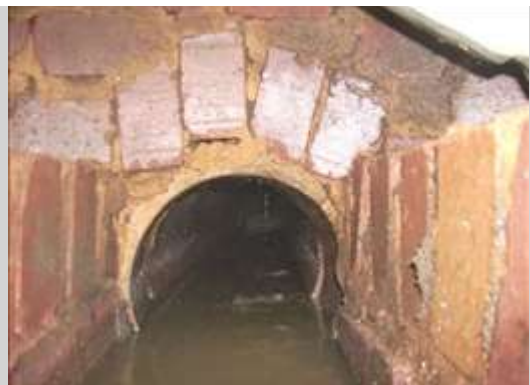
6 O'Clock Inflow

8 in. Circular Gravity Sewer
Pipe In @ 6 O'Clock

Deposits: ☐ None ☐ Mud ☐ Sludge ☒ **Debris** ☐ Grease

Silt Depth: **2** (in.) Deposits Extent: **Medium**
